External Research Report ER53 [2020]

# Measuring the Extent of Thermal Bridging in External Timber-Framed Walls in New Zealand

Verney Ryan, Guy Penny, Jane Cuming, Ian Mayes, Graeme Baker, Beacon Pathway Inc.

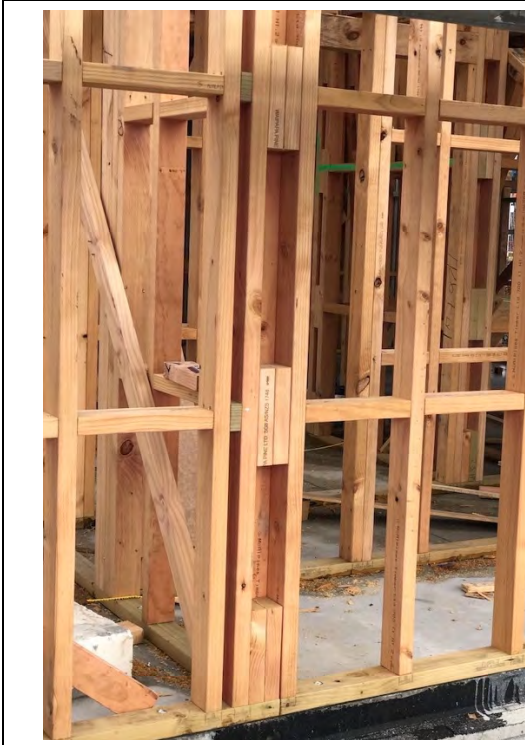
An example of an internal wall to external wall junction prior to building paper going on – note the large voids which, in all likelihood, will remain uninsulated

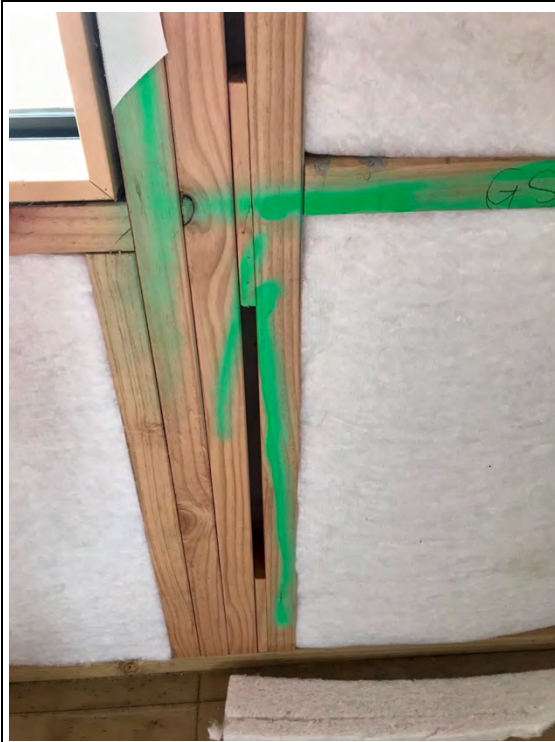
An example of timber fillet packing in the framing which leaves an uninsulated gap in the thermal envelope

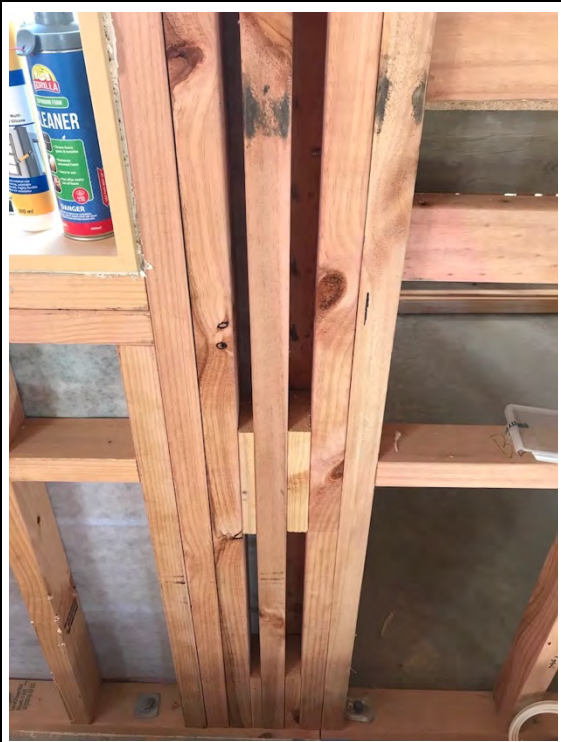
An example of packing in the framing which mitigates against getting insulation into these small and inaccessible spaces. Spray in expanding foam may be the only solution in these areas

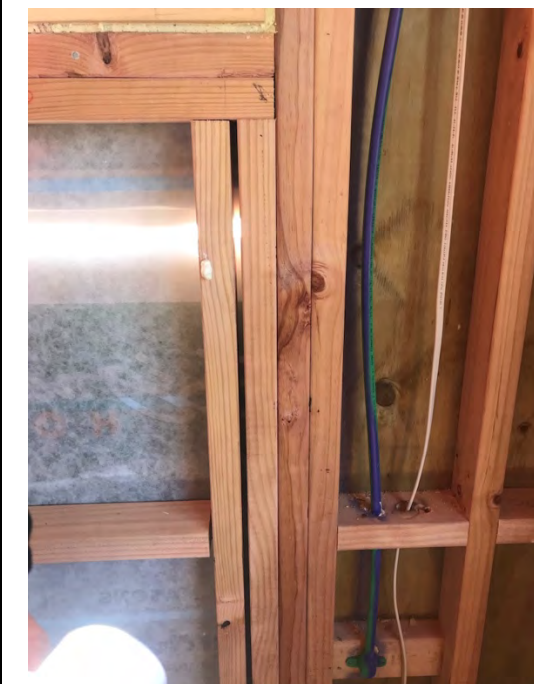
This gap between these two studs will be hard to fill with insulation and will be a significant source of heat loss in this section of the wall

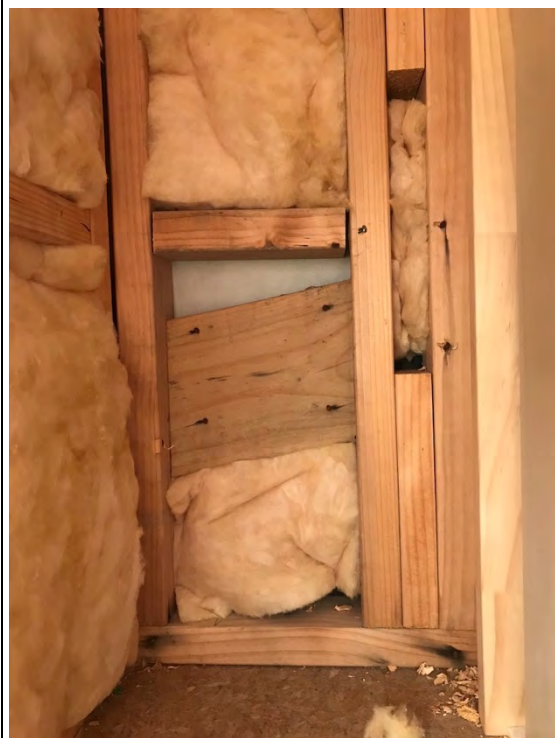
140mm blocking on edge to support flashing for the apron roof – noting that the 45mm face remains uninsulated as well as the awkward gap left behind in the space above it

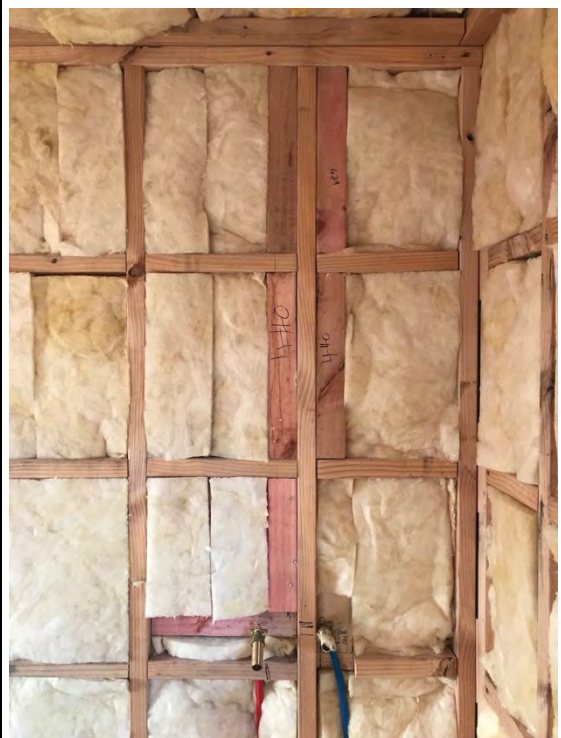
90mm blocking on edge to take plumbing pipe fixtures – the 45mm space behind this edge fitted timber remains uninsulated

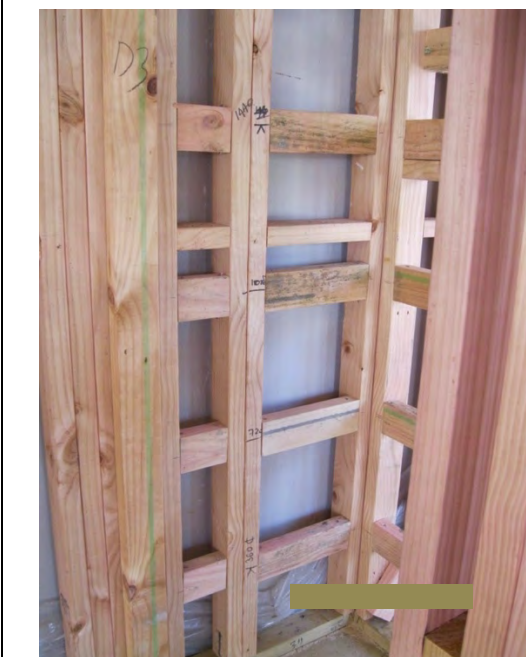
The effect of added blocking to support shelving in a cupboard space – note also the uninsulated internal to external wall junctions

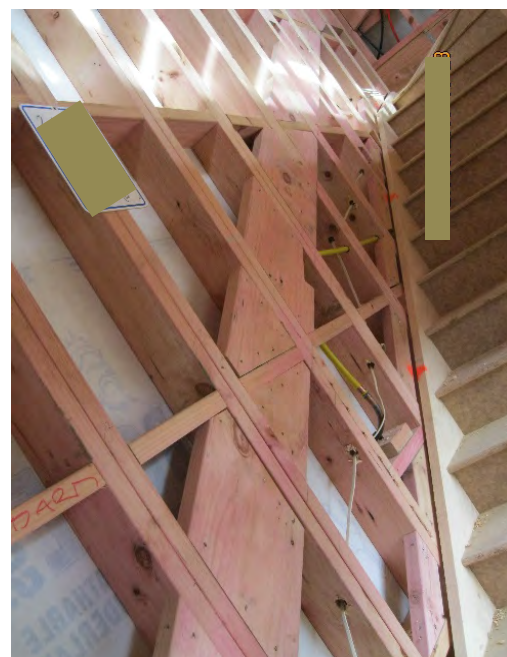
Photograph taken looking up the stairs and showing a large expanse of added blocking to take a handrail

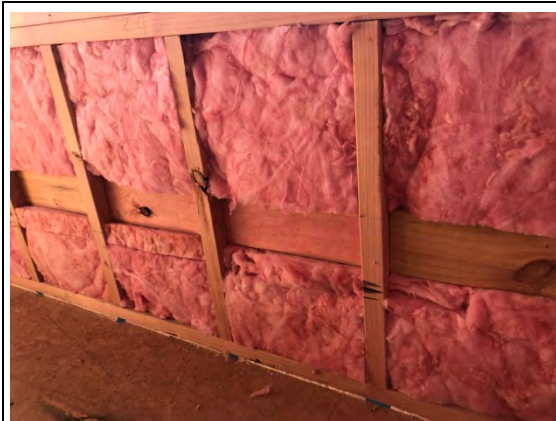
140mm blocking on edge to support flashing for the apron roofing – note that the remaining 45mm X 140 mm gap on the face remains uninsulated

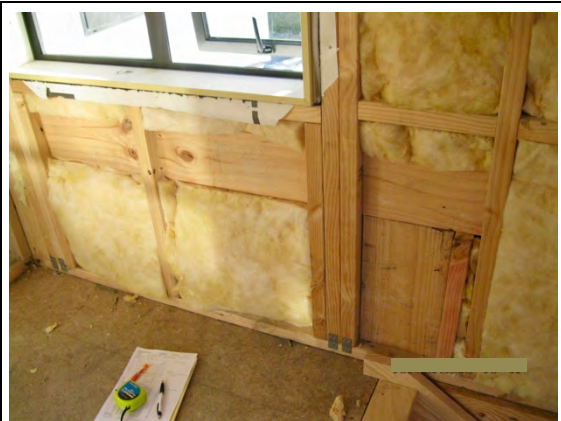
A large area of blocking added across several wall panels to take an apron roof flashing

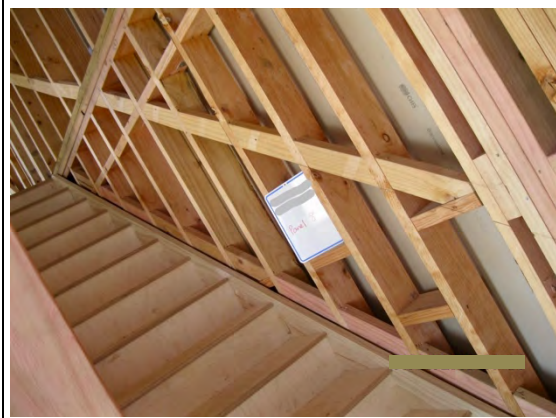
Image showing added framing for fixing handrail (on diagonal) as well as framing at 300mm centres despite 140mm timber sizing

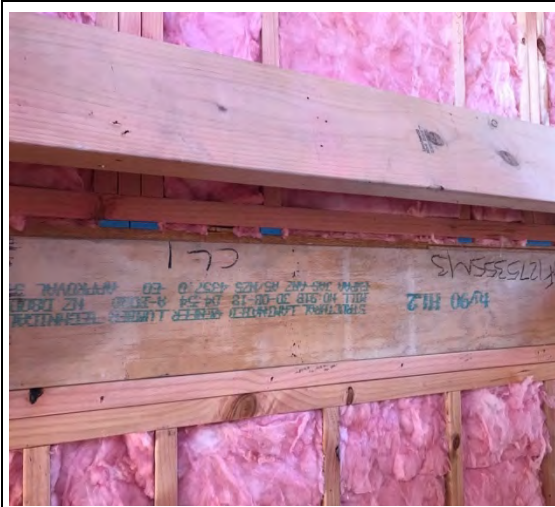
A midfloor section (photographed from within the stairwell) indicating the large uninsulated 'ribbon' right around the house between the two floors

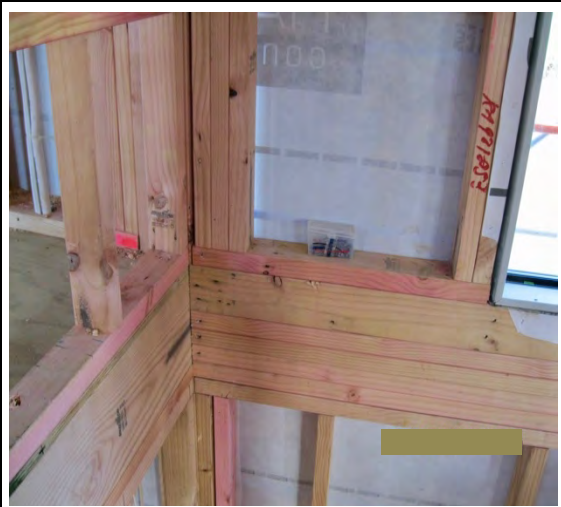
A built up section of midfloor indicating the extent of the uninsulated solid timber thermal bridge (approximately 410mm) created between the two levels

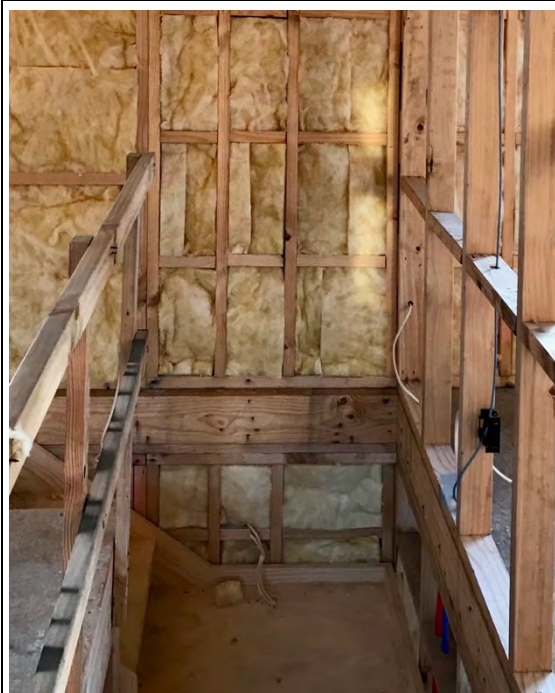
A midfloor 'ribbon' photographed half way up the stairs

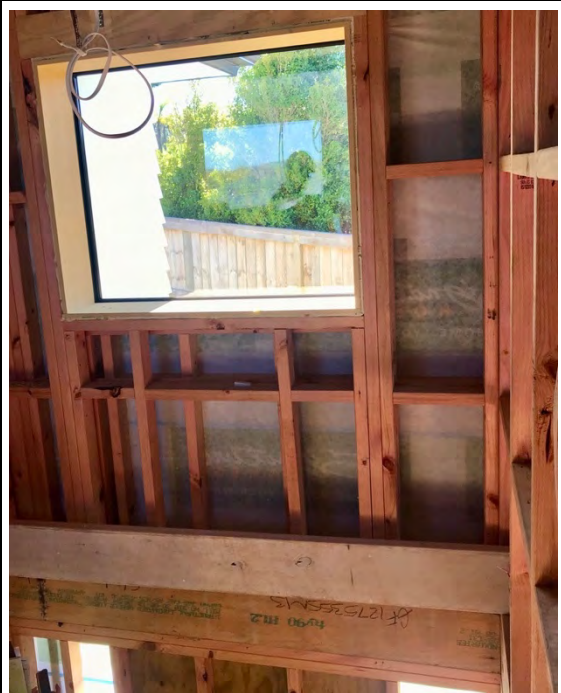
A midfloor junction in the open void of a large stairwell

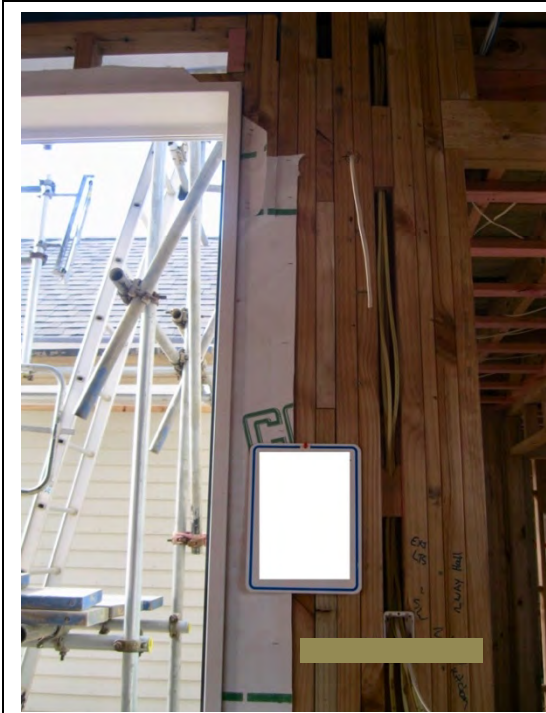
An example of a five-stud corner next to multiple trim studs to account for the window opening

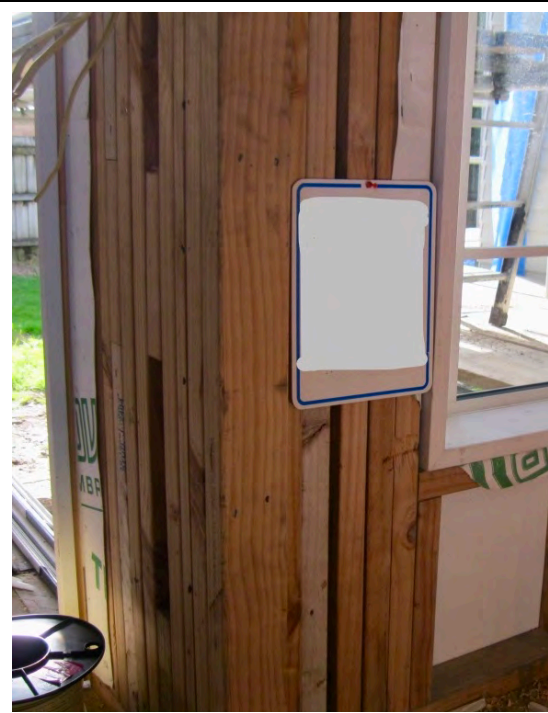
High concentration of corner framing leaves this external corner almost completely uninsulated

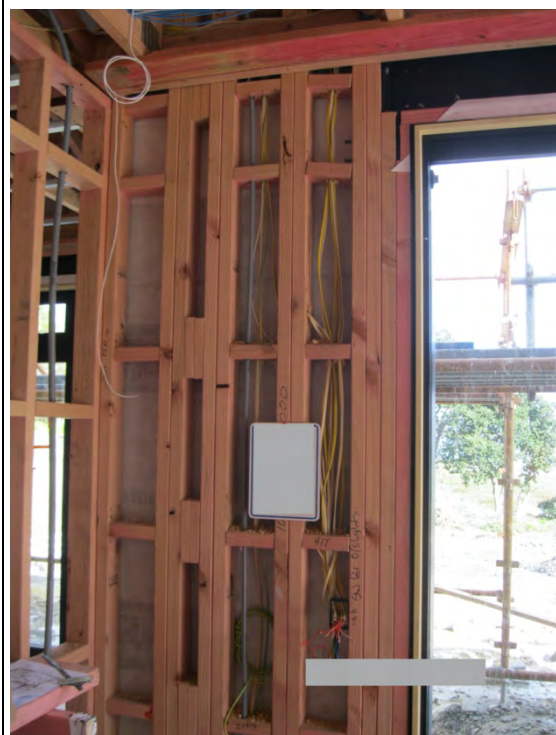
A high percentage of framing with close noggling, blocking and multiple studs next to a large window

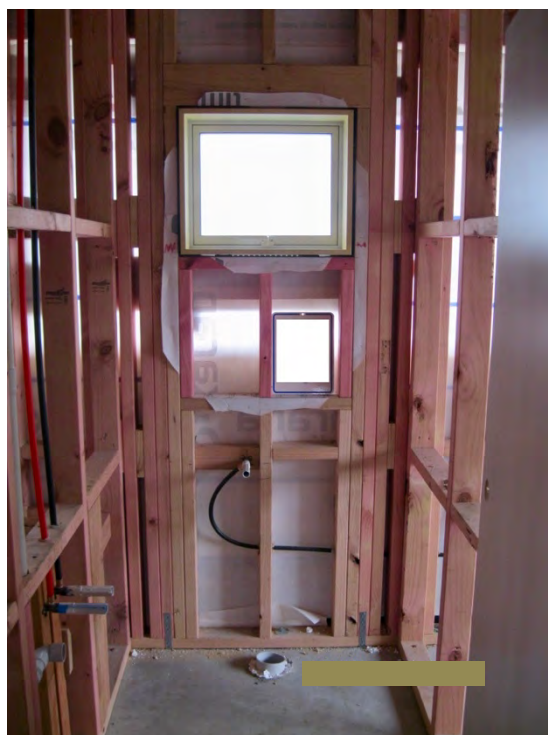
Two internal wall junctions in a small toilet wall next to an opening. This results in a high percentage of framing in this wall – in an area that may be prone to condensation

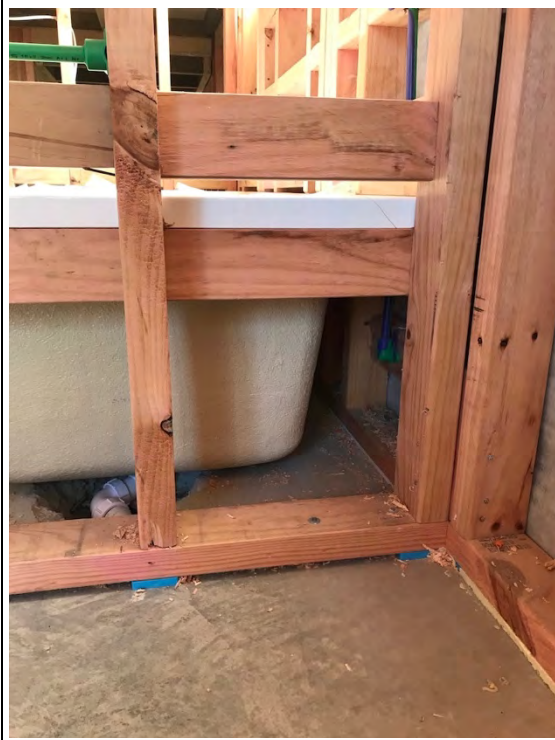
An uninsulated wall behind a bath – in this case the timing of the trades works against this being insulated properly

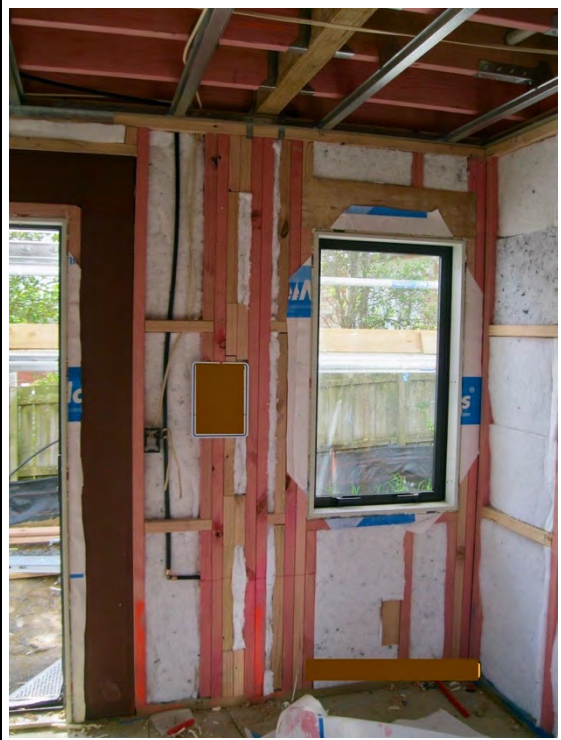
Large steel portal (uninsulated) around door and adjacent to a wall with a high percentage of framing

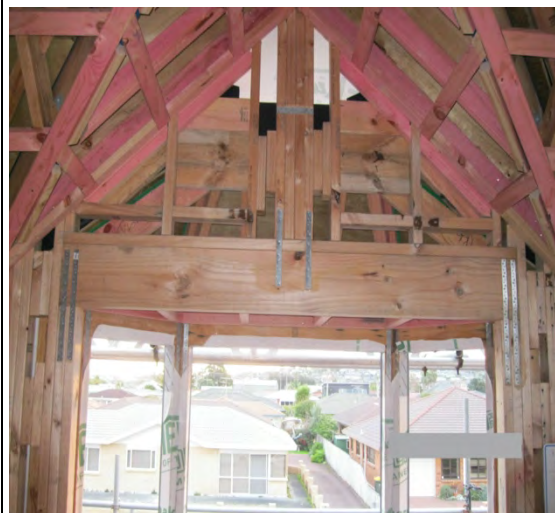
High concentration of framing and a combination of difficult shapes making insulation difficult

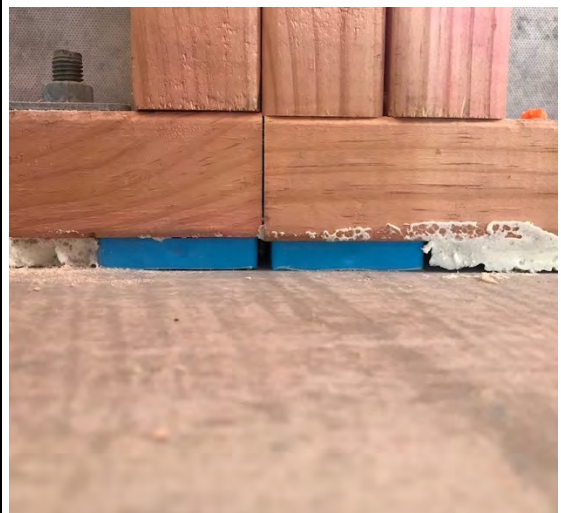
The plastic packer under the bottom plate – in this instance with gaps and less than adequate expanding foam under the full width of the bottom plate

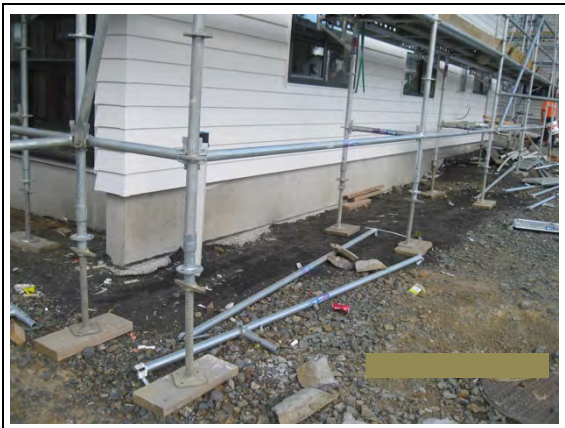
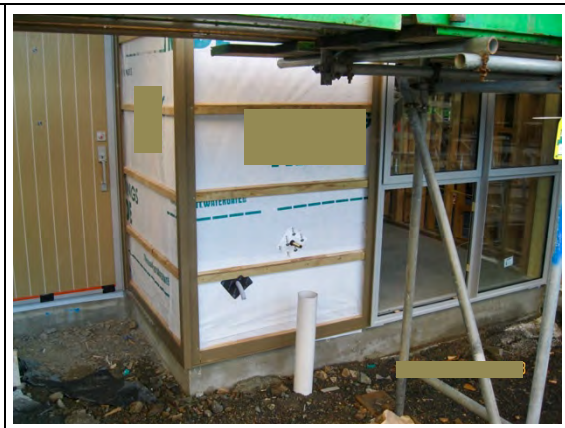
<p>Large raised and uninsulated concrete slab perimeter.</p>	<p>Typical concrete slab – uninsulated around the perimeter.</p>

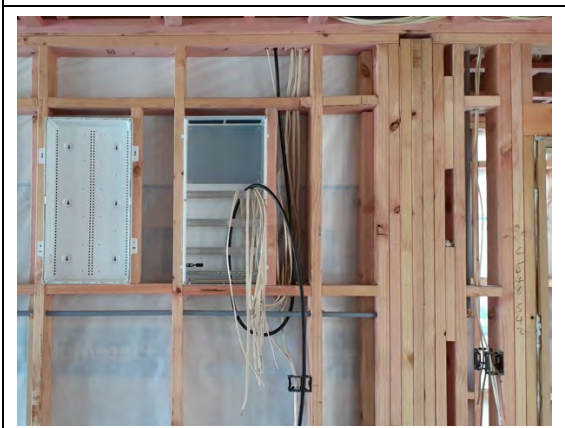
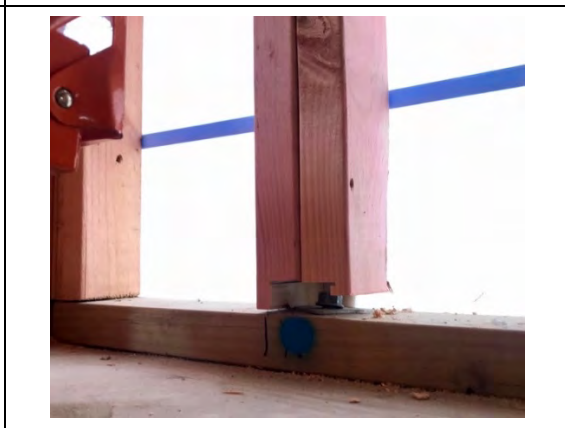
<p>Wiring and pipework in external walls made insulation installation challenging</p>	<p>An example of cutting away supporting stud work to affix a hold down bolt</p>

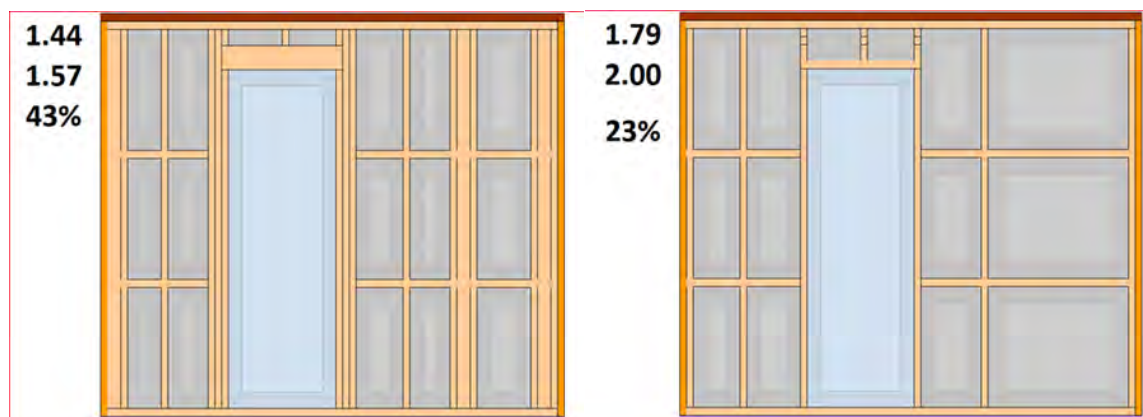
**Figure 8: Actual timber framing (left) compared to allowable definitions under NZS 4218 (right)**

The drawing below<sup>6</sup> illustrates the difference between the actual framing installed on site from a single case study wall panel when compared to how the wall is set out in the definition provided in NZS 4218 - which effectively allows the user to ignore the thermal bridging of lintels, trimming and double studs etc.

The figures shown in the top left of each drawing indicate the following; firstly the achieved R-value with R2.0 insulation in the voids, then the achieved R-value with R2.8 insulation installed (the maximum that is currently achievable in a 90mm cavity), and then the third figure describes the percentage of framing that make up that wall panel.

This is only a single example and it is recommended that future research explore this in more detail – ideally, calculating the effective construction R-value in a direct comparison between the actual timber installed on site and the NZS 4218 definition.

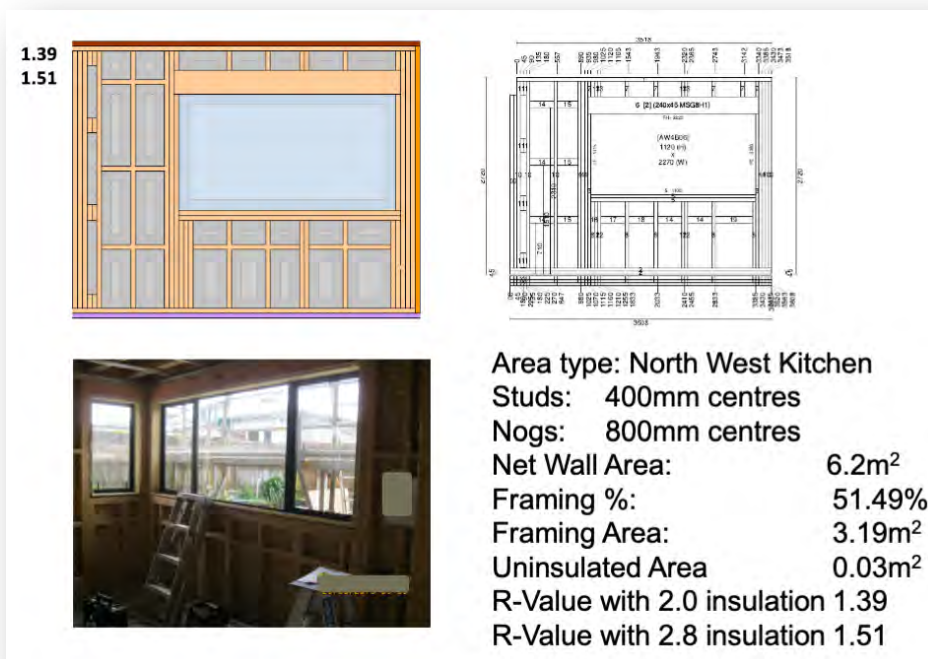
Figure 11: Northwest kitchen wall showing wall area, layout and resulting R-value

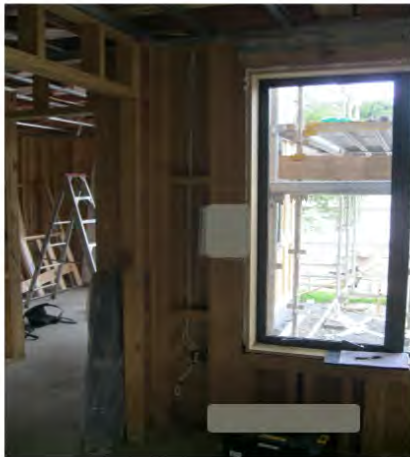
Area type: South East Living  
 Studs: 400mm centres  
 Nogs: 800mm centres  
 Net Wall Area: 5.6m<sup>2</sup>  
 Framing %: 57.99%  
 Framing Area: 3.25m<sup>2</sup>  
 Uninsulated Area 0.m<sup>2</sup>  
 R-Value with 2.0 insulation 1.21  
 R-Value with 2.8 insulation 1.29

Figure 14: Southeast living room wall showing wall area, layout and resulting R-value
